Technical Note

Percutaneous femoral access: Stuck guide wire, decannulation difficulty due to unravelling and knotting

J Cerebrovasc Endovasc Neurosurg.
March 27, 2024 [Epub ahead of print]

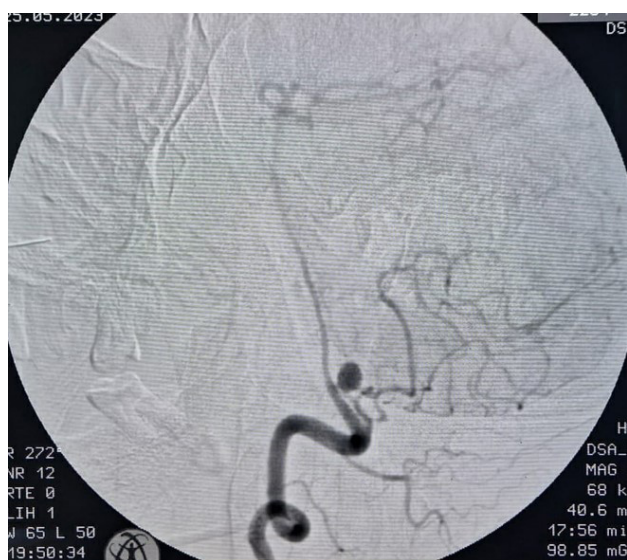
Fig. 1. Cerebral DSA selective shoot of right vertebral artery showing right proximal PICA aneurysm. DSA, digital subtraction angiography; PICA, posterior inferior cerebellar artery

A 55 year old, moderately built female, on presenting with headache, was diagnosed with unruptured right proximal posterior inferior cerebellar artery (PICA) aneurysm (Fig. 1) by diagnostic cerebral digital subtraction angiography (DSA), which was uneventfully accomplished by right femoral artery access in first attempt with smooth cannulation via single wall Seldinger technique. Subsequently, after 2 days, she was taken up for

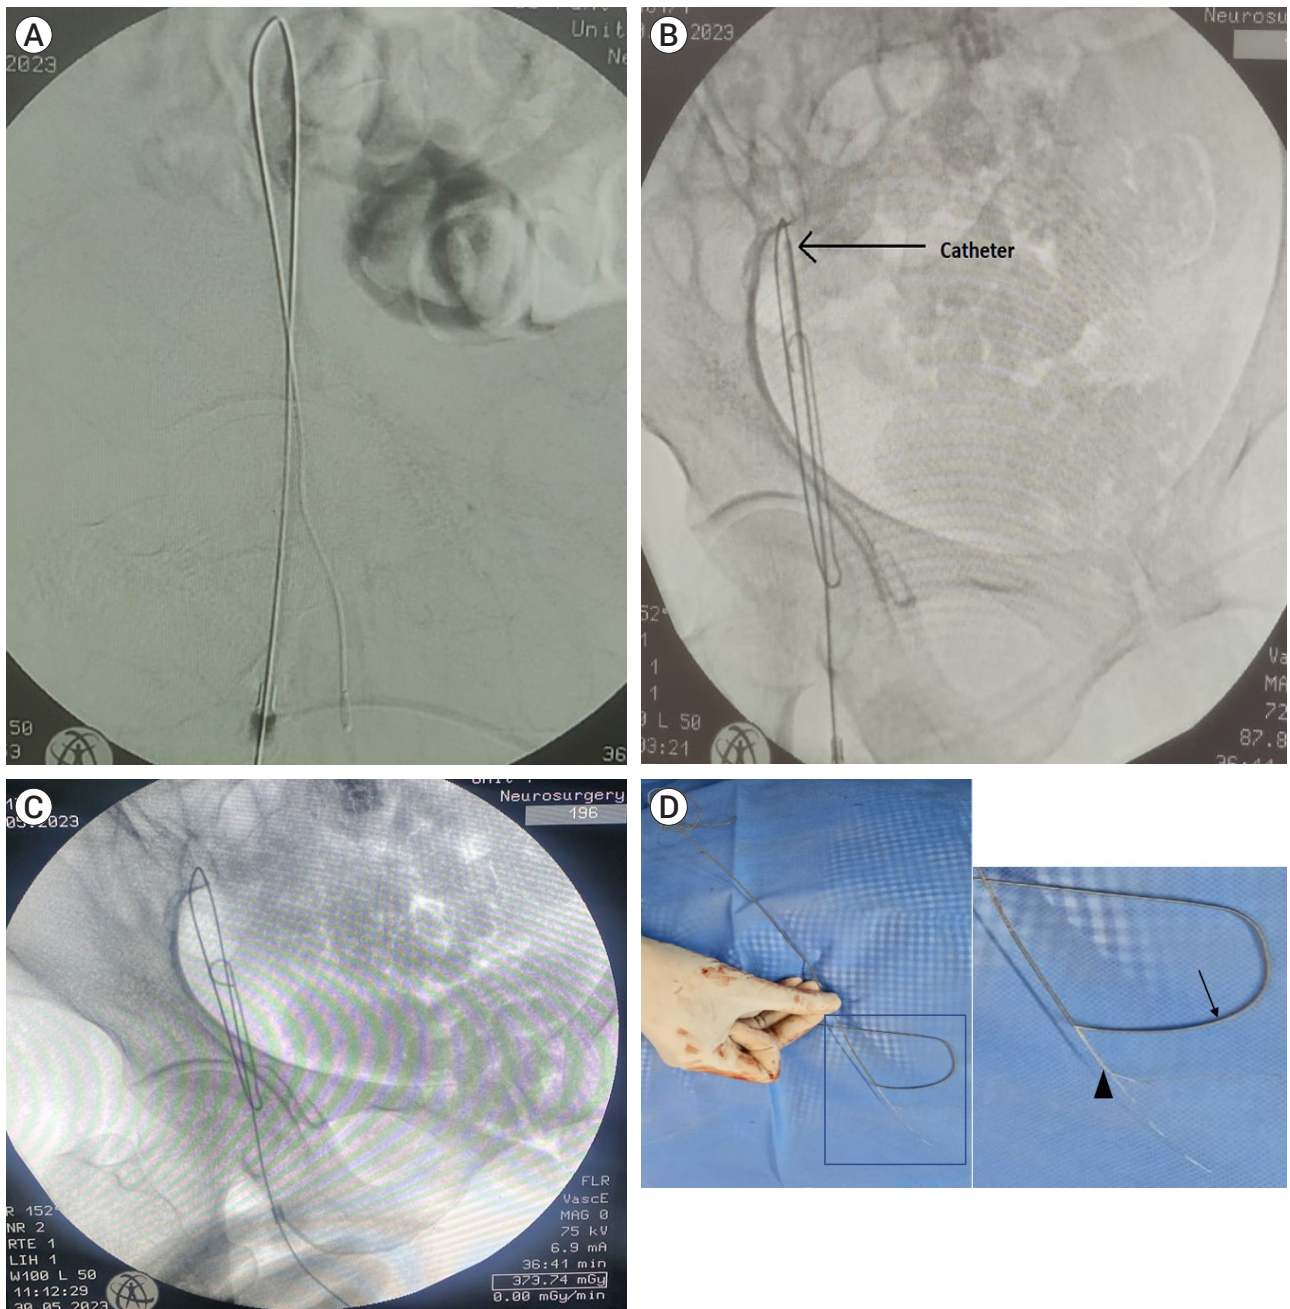
Fig. 2. (A) Fluoroscopic image showing check flow with guide wire, and its inferiorly directed loop in the femoral artery. (B) Fluoroscopic image showing multiple loops and knotting of guide wire in the common femoral artery. (C) Fluoroscopic image showing MPC (catheter) negotiated upto the first bend, couldn't be negotiated any further, and failed to straighten the wire. (D) Image showing distal end has separated into rigid central core (arrow head) and overlying soft part (arrow), which has unraveled (box magnified view). Multiple loops formed by the unraveled soft part seen in the proximal end after removal. MPC, multipurpose catheter

therapeutic intervention by endovascular coiling, for which again percutaneous right femoral access was planned by manual palpatory method, via entry point 1.5 cm below the mid inguinal point. After initial puncture with single wall Seldinger technique using 18G puncture needle, guide wire (diameter 0.038", length 45 cm, J tip) was introduced, which went through with little resistance. Puncture needle was removed, and 7F introducer sheath was threaded over the wire as standard practice, after placing the nick on skin and subcutaneous tissue. On attempting to withdraw the wire with introducer sheath, significant resistance was encountered, resulting in failure of removal. Immediately, puncture site was visualised under fluoroscopy guidance, and guide wire was found to be bent, with an inferiorly directed loop in the femoral artery (Fig. 2A). However, position of introducer sheath was confirmed in the lumen by good back flow of blood from the side channel. Multiple attempts were made to remove the wire by to and fro movement, by pushing it to straighten it, by pulling it against resistance, but everything failed. Instead of straightening, the wire looped several times (Fig. 2B). Next, an attempt was made to pass a 5 French multipurpose catheter (MPC) over the wire through the diaphragm of the check flow, which could only be negotiated till the first bend of wire (Fig. 2C). The discrepancy in the length of MPC (90 cm), over the wire (45 cm), was resolved by cutting the MPC, till proximal part of guide wire was visualised. Introducer sheath was withdrawn, and attempt was made to remove the entire assembly en masse, which also failed. Cardiothoracic and Vascular surgeons' team was summoned for help and planned for arteriotomy and removal, during which, after removal of MPC, it was noticed that distal guide wire was broken and had gotten separated into rigid straight central core and overlying soft coiled part which became unravelled (Fig. 2D). On final attempt by grasping the rigid core wire, using improvised rotational manoeuvre simultaneously with pulling, the proximal end got dislodged and retrieval was successful. Immediately the access site was compressed manually, after haemostasis was ensured, good femoral and dorsalis pedis pulsations

cannulations, literature regarding knot formation while cannulating the artery in one attempt is scarce, and retrieval of such kinked and unravelled wire, without major morbid complications is even scarcer.²⁾ Here, the suspected causes are speculated to be overly malleable and faulty guide wire, inadequate nick over skin and subcutaneous tissue leading to introducer sheath tip damage due to forceful insertion against resistance (damaged tip can damage the wire as well as intima during manipulation), repeated attempt via the same side within short interval, and forceful introduction of wire against even slight resistance. One must exert extreme caution while selecting the entry point, and inspect the hardware minutely before the procedure, and keep extremely low threshold for resistance and manoeuvring difficulties, to avoid such incidents.
